DEPARTMENT OF TRANSPORTATION

Federal Aviation Administration

[Docket No. FAA-2012-0631; Directorate Identifier 2011-SW-021-AD]

Airworthiness Directives; Eurocopter France Helicopters

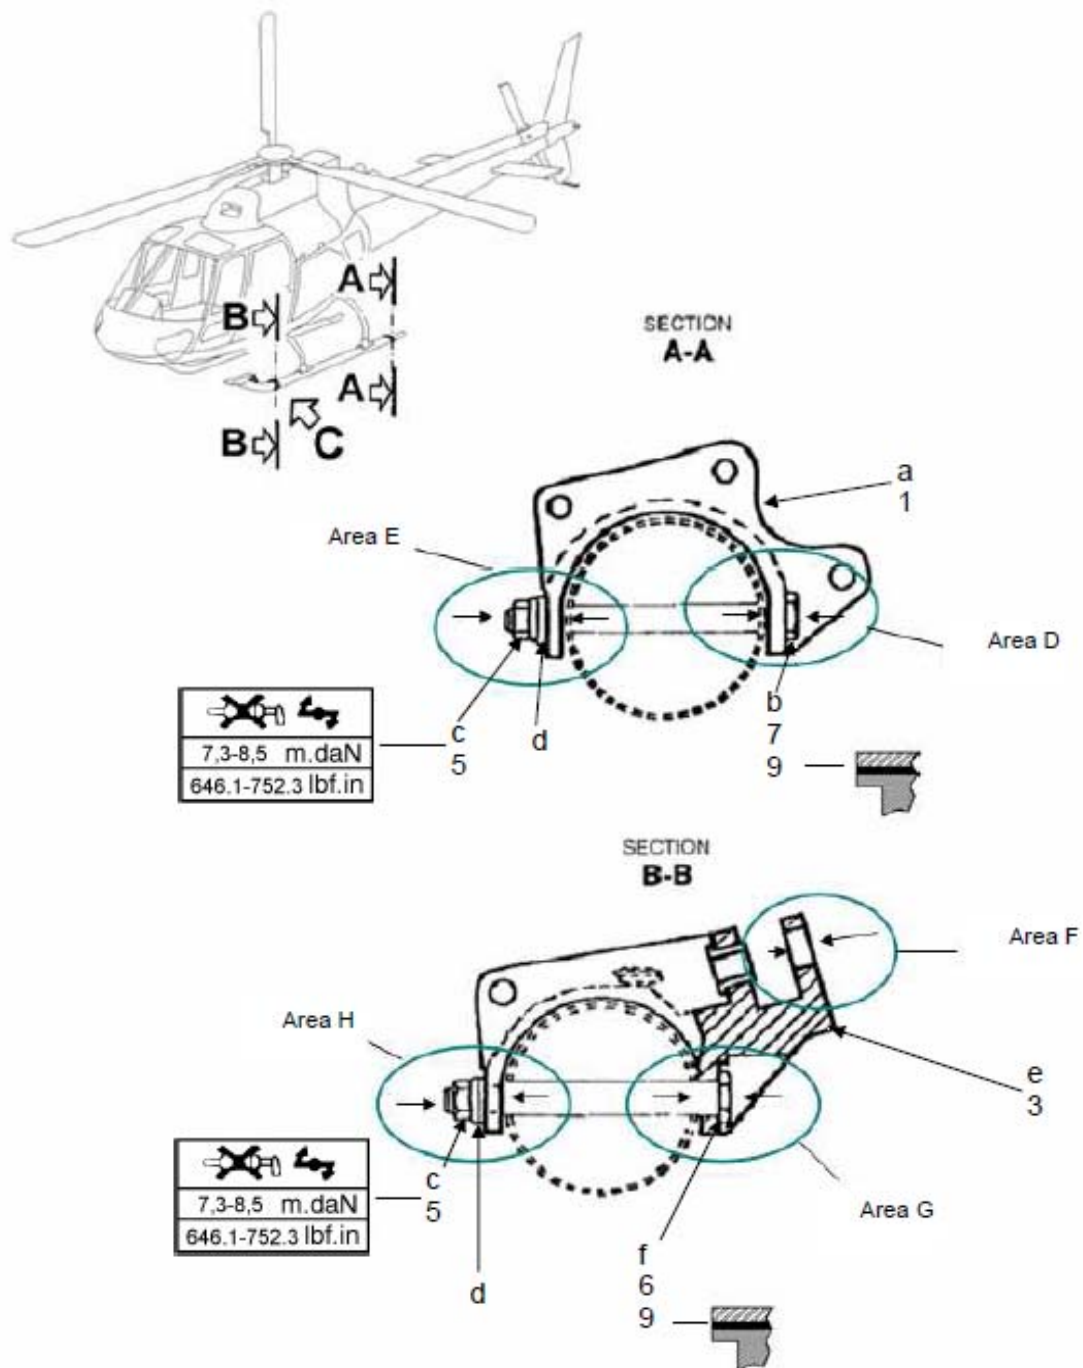
Figure 1. Emergency Flotation Gear Attachment Brackets

of cracks being found on the brackets which appear to be caused by stress corrosion. This condition, if not corrected, could result in “rupture of the emergency flotation gear attachment brackets” during a water landing, no longer ensuring float stability of the helicopter, possibly resulting in damage to the helicopter and injury to the occupants. The EASA’s AD requires an initial inspection of the brackets, replacement of any brackets found with cracks, and re-inspection of the brackets every 13 months.

This AD defines the unsafe condition as a crack in an attachment bracket of the emergency flotation gear. This condition could result in failure of the emergency flotation system and loss of float stability in the event of a water landing.

(1) Using a 5x or higher power magnifying glass, visually inspect the front emergency flotation gear attachment bracket (Figure 1 of this AD, section B-B, item (e)) in Areas F, G, and H; and the rear emergency flotation gear attachment bracket (Figure 1 of this AD, section A-A, item (a)) in Areas D and E for a crack.

(2) If there is a crack, replace the cracked emergency floatation gear attachment bracket with an airworthy emergency floatation gear attachment bracket prior to reinstallation of the emergency flotation equipment.
